# Cyclops restoration programme October 2025

## A summary of the work carried out in the Month of Oct. 2025

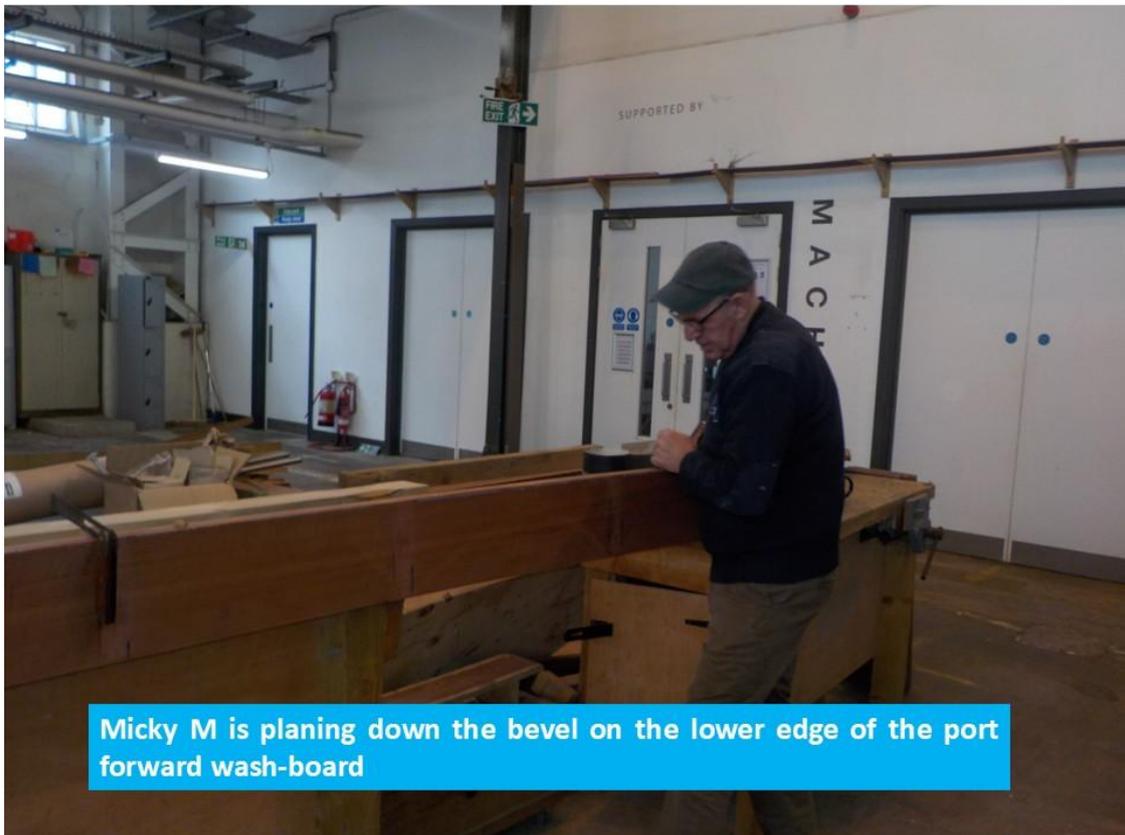
Micky M is planing down the bevel on the lower edge of the port forward wash-board

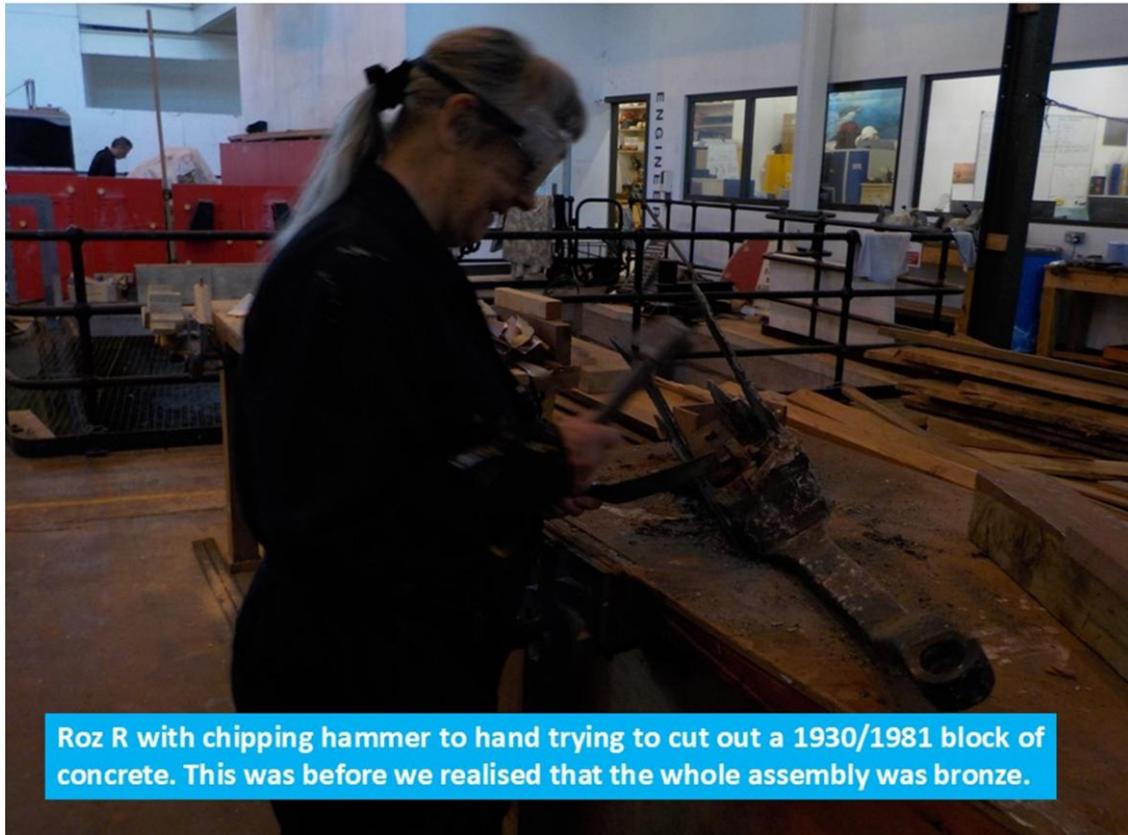
Roz R with chipping hammer to hand trying to cut out a 1930/1981 block of concrete. This was before we realised that the whole assembly was bronze.

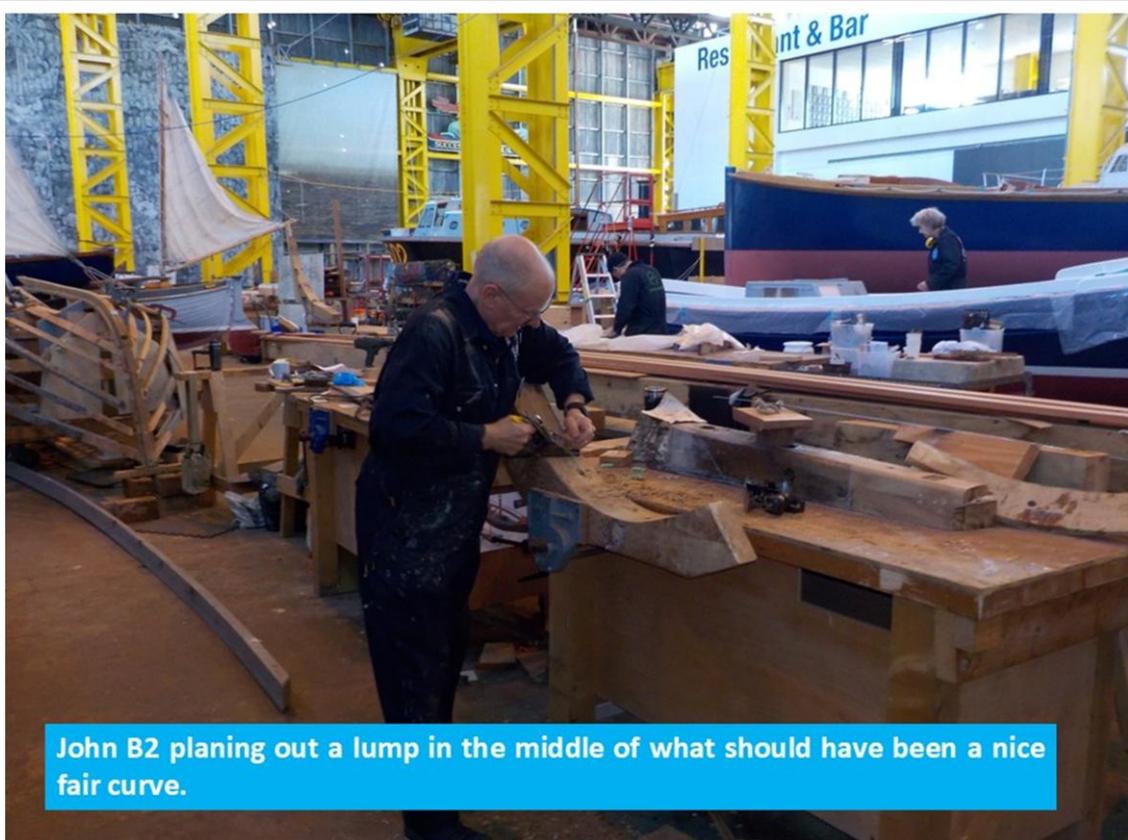
John B2 planing out a lump in the middle of what should have been a nice fair curve.

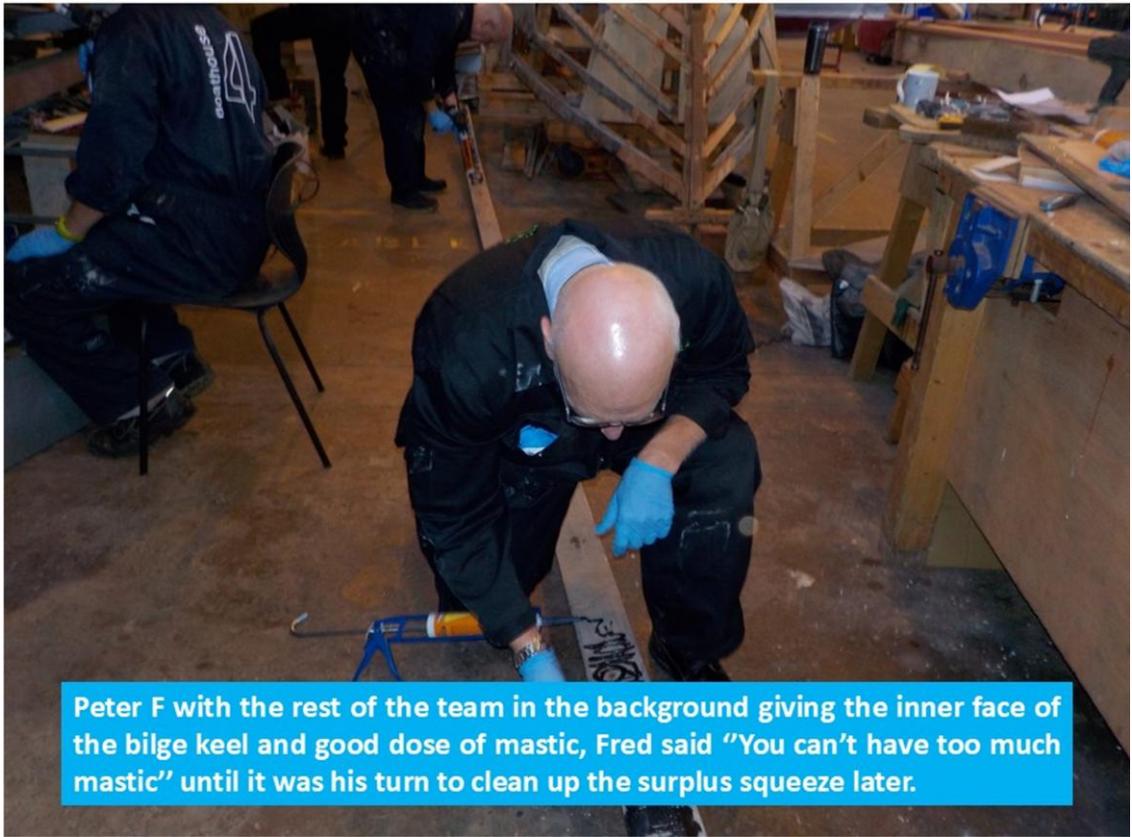
Peter F with the rest of the team in the background giving the inner face of the bilge keel and good dose of mastic, Fred said "You can't have too much mastic" until it was his turn to clean up the surplus squeeze later.

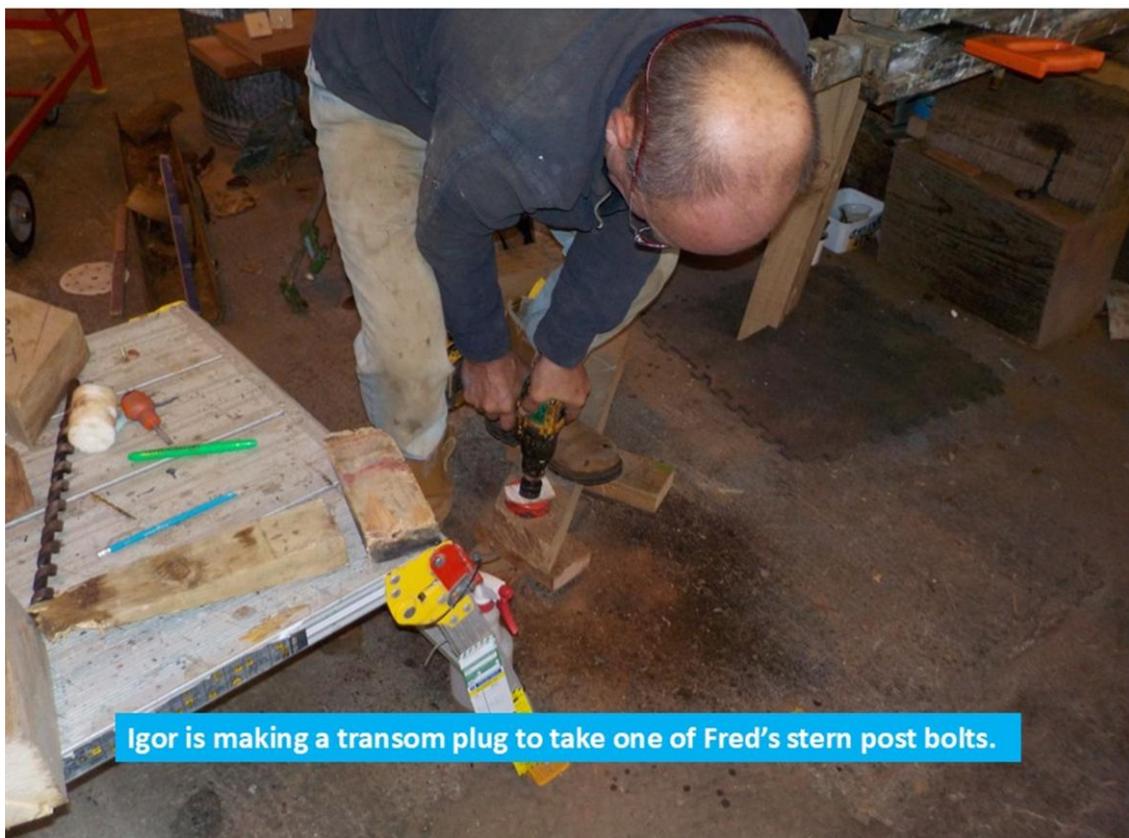
Igor is making a transom plug to take one of Fred's stern post bolts.

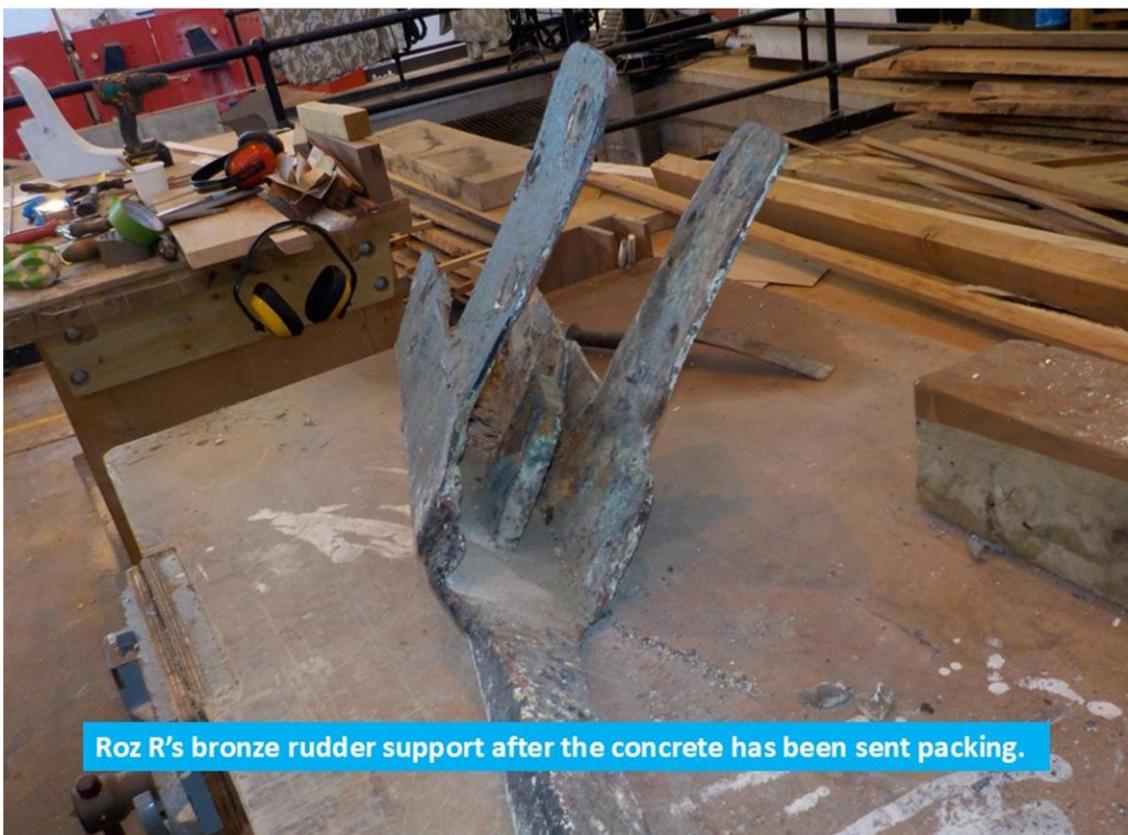
Roz R's bronze rudder support after the concrete has been sent packing.

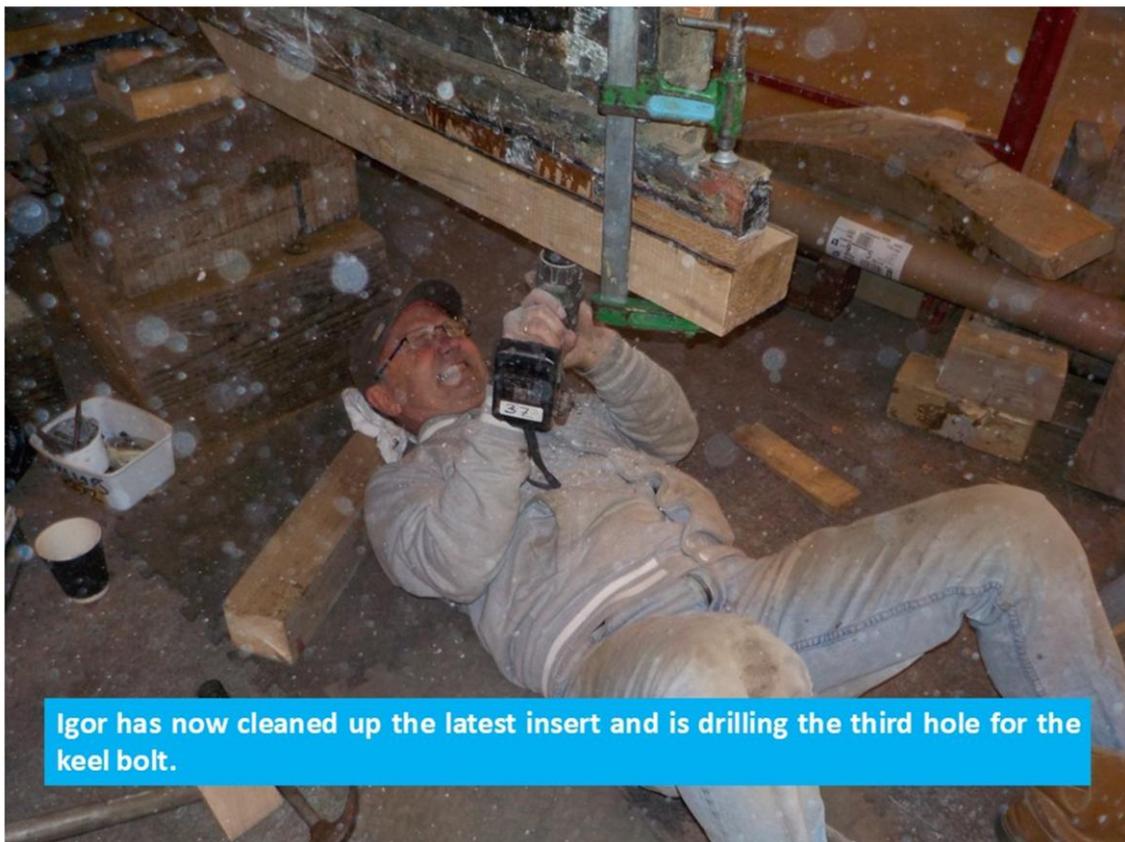
Igor has now cleaned up the latest insert and is drilling the third hole for the keel bolt.

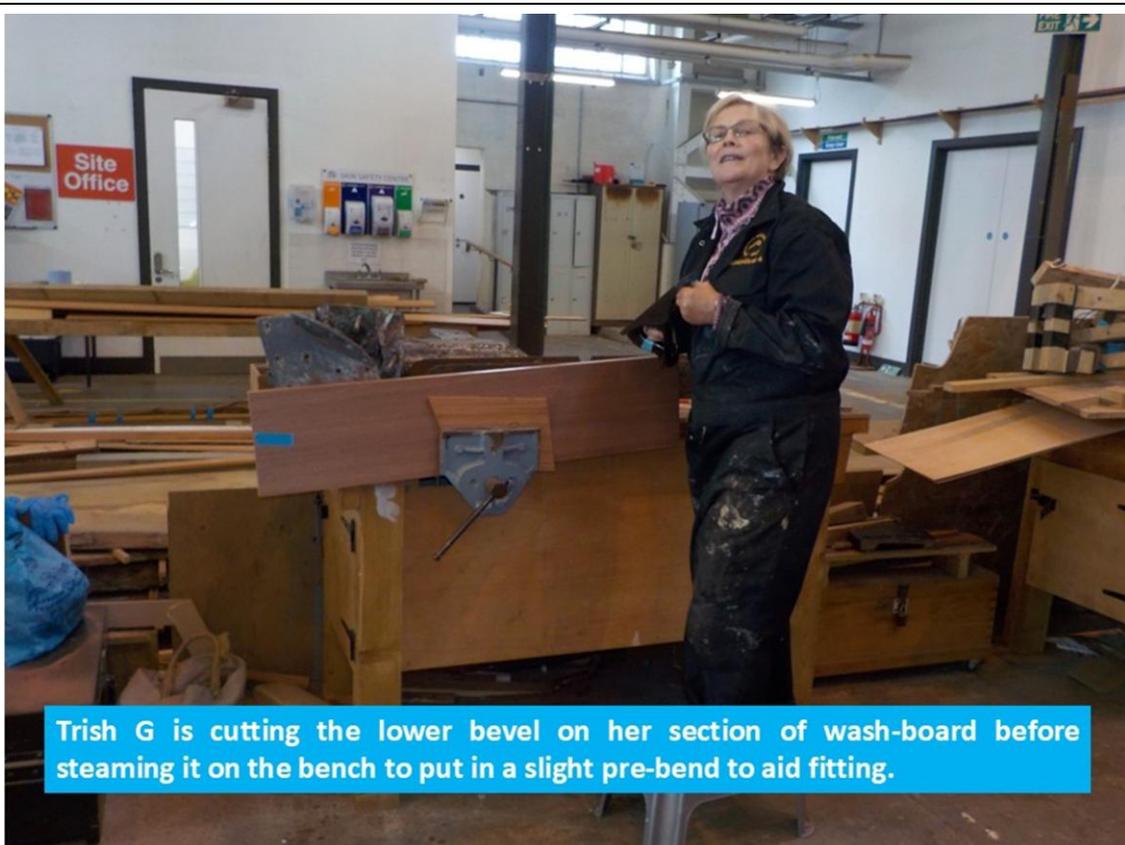
Trish G is cutting the lower bevel on her section of wash-board before steaming it on the bench to put in a slight pre-bend to aid fitting.

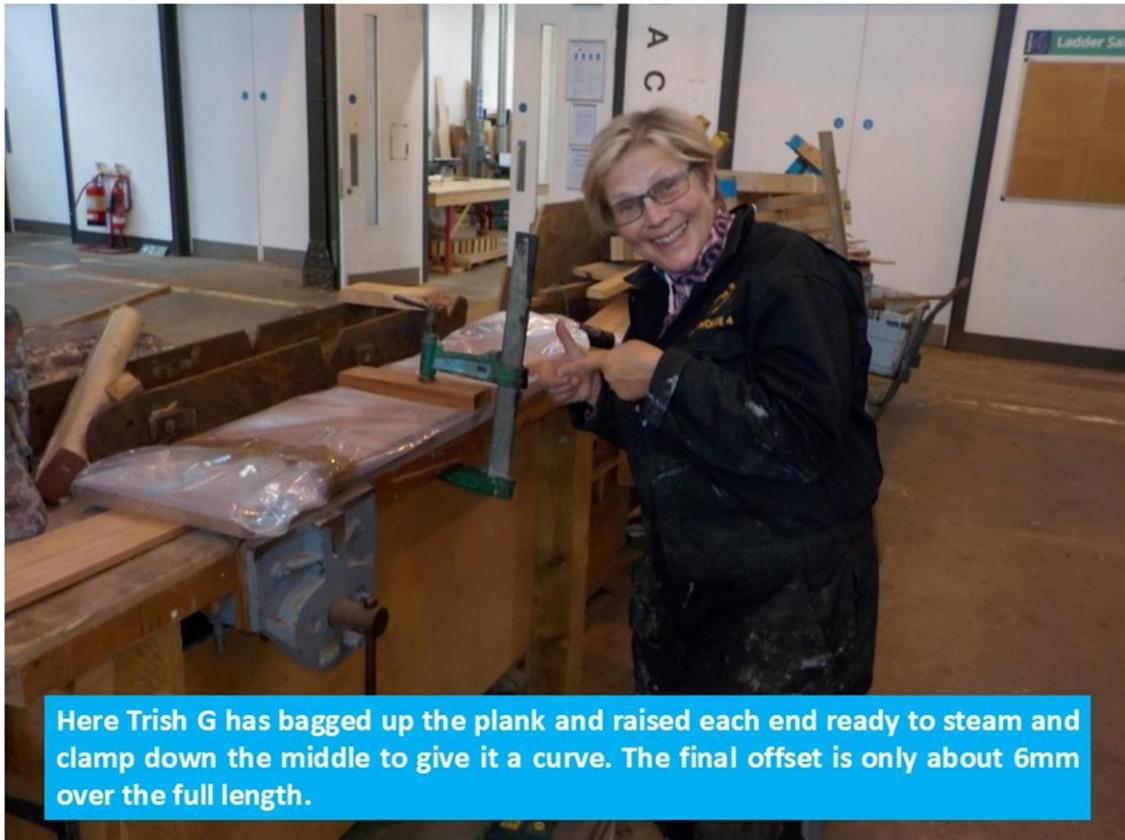
Here Trish G has bagged up the plank and raised each end ready to steam and clamp down the middle to give it a curve. The final offset is only about 6mm over the full length.

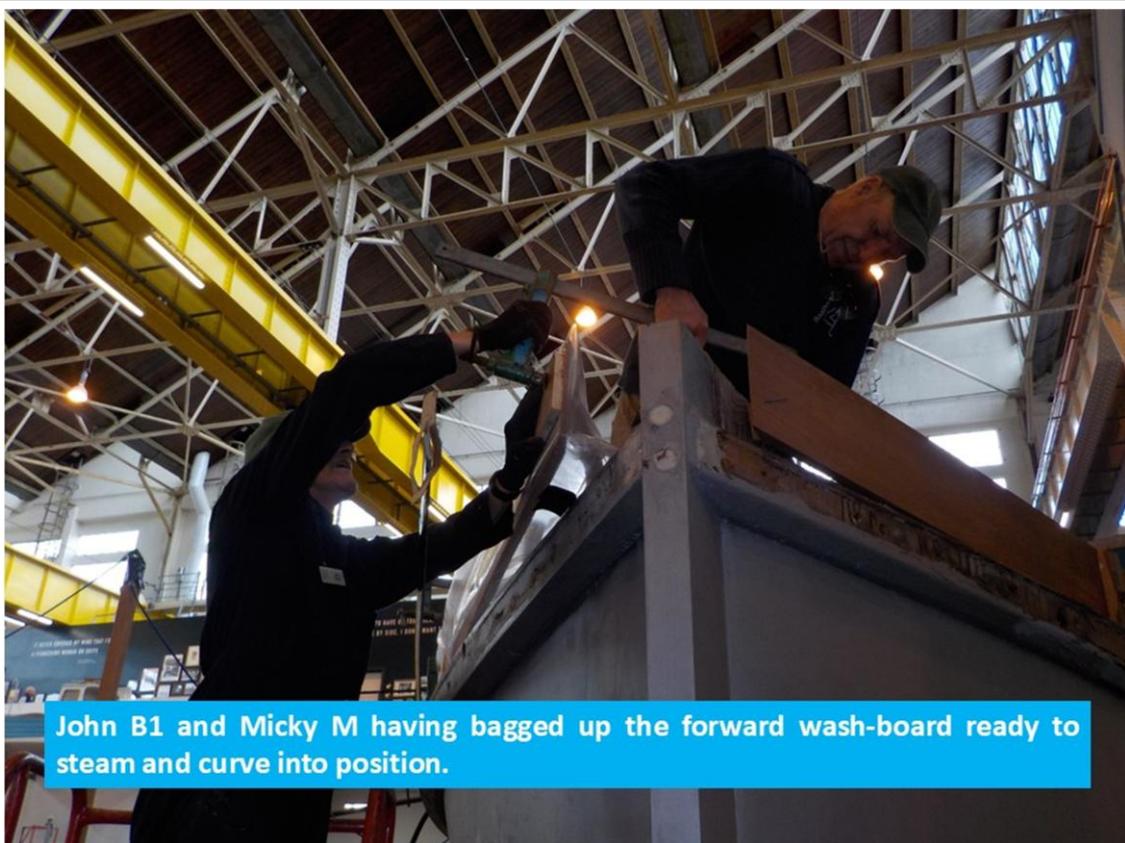
John B1 and Micky M having bagged up the forward wash-board ready to steam and curve into position.

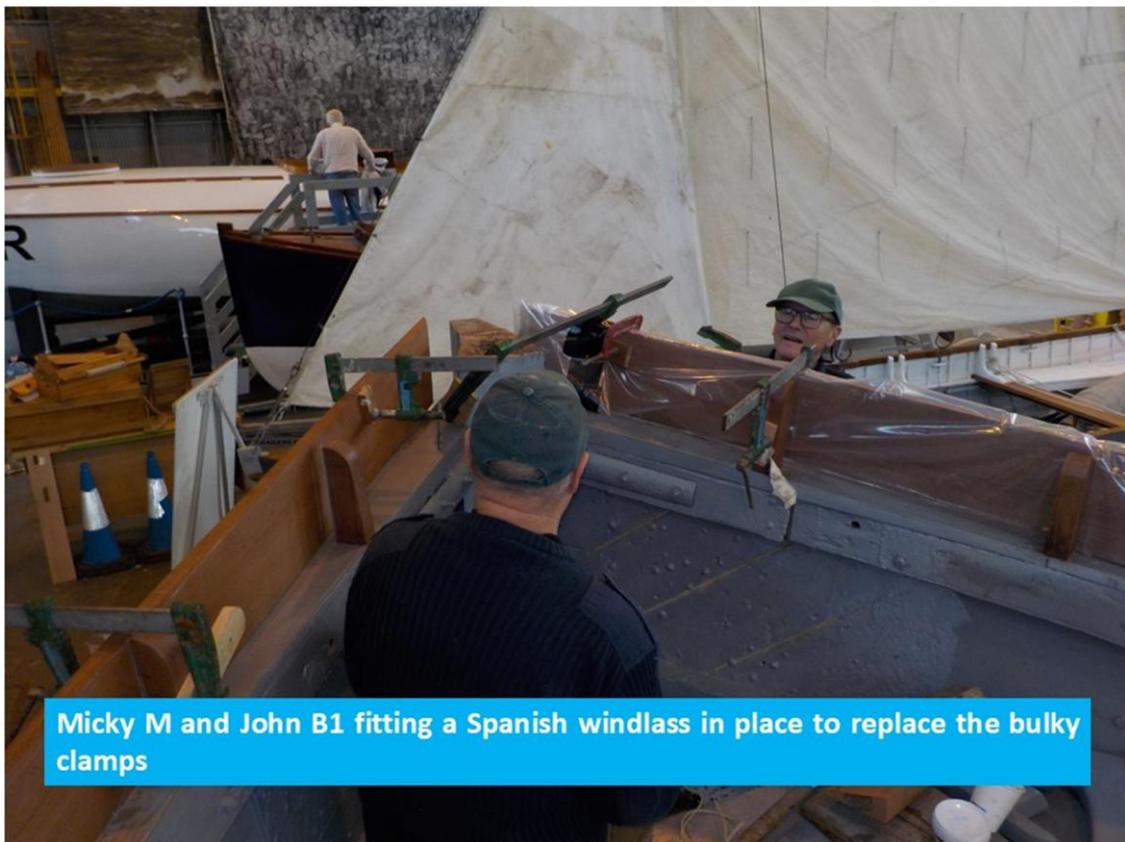
Micky M and John B1 fitting a Spanish windlass in place to replace the bulky clamps

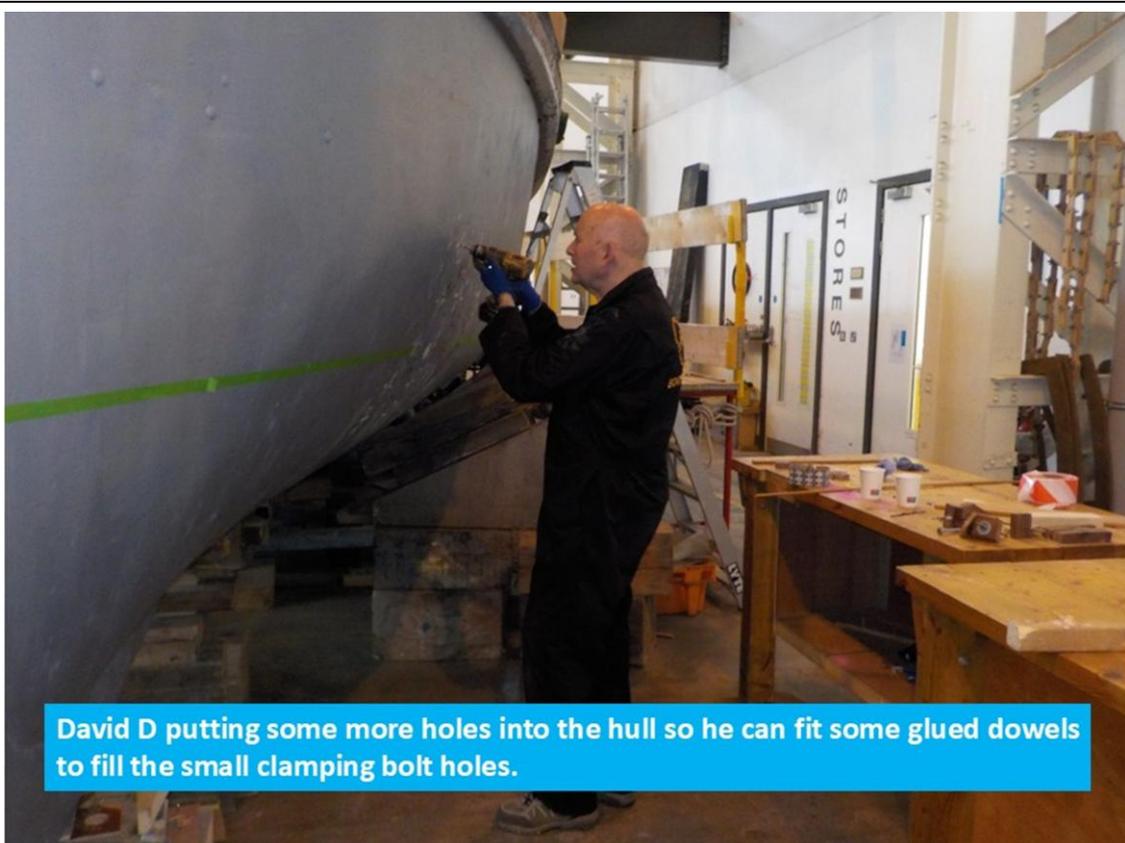
David D putting some more holes into the hull so he can fit some glued dowels to fill the small clamping bolt holes.

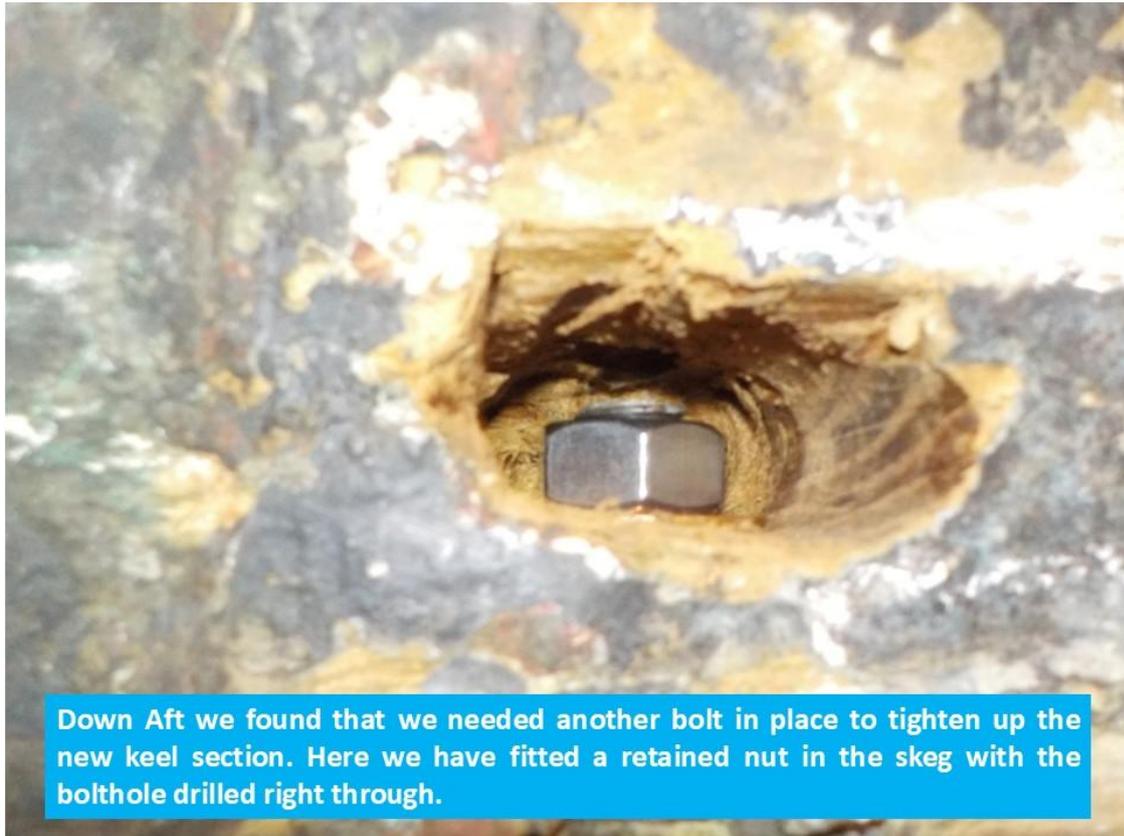
Down Aft we found that we needed another bolt in place to tighten up the new keel section. Here we have fitted a retained nut in the skeg with the bolthole drilled right through.

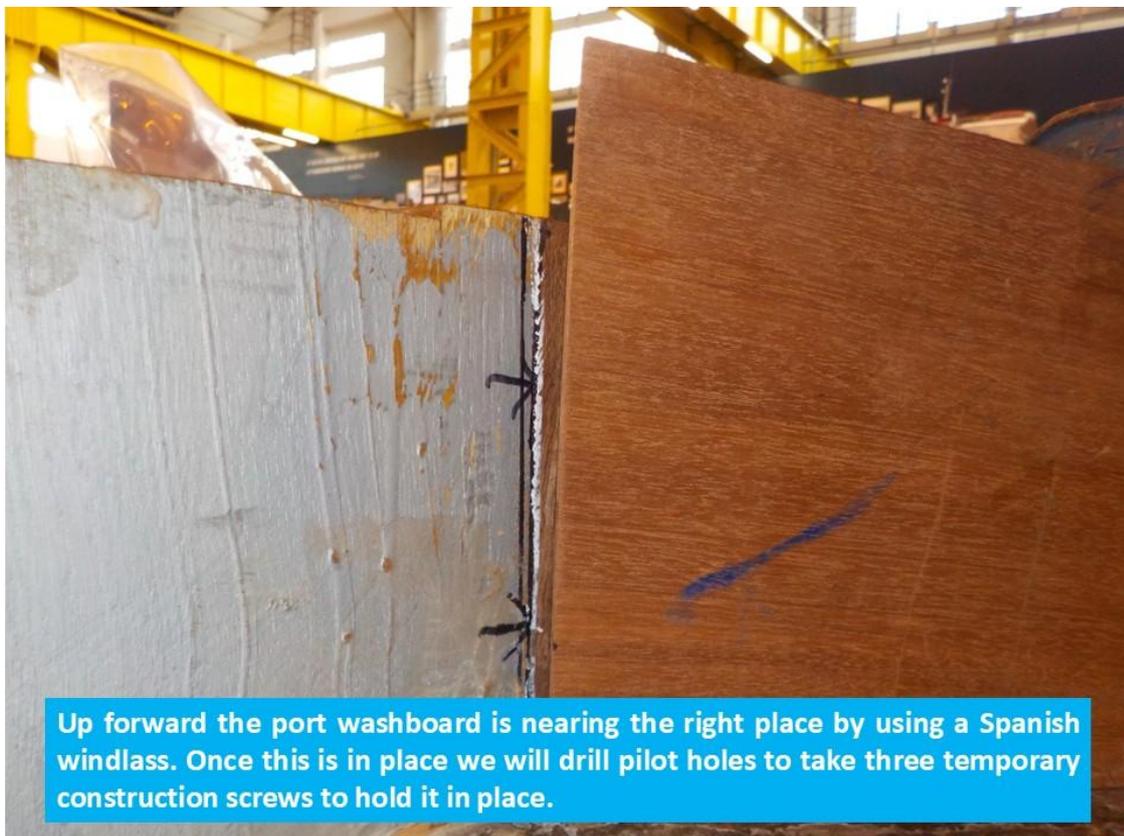
Up forward the port washboard is nearing the right place by using a Spanish windlass. Once this is in place we will drill pilot holes to take three temporary construction screws to hold it in place.

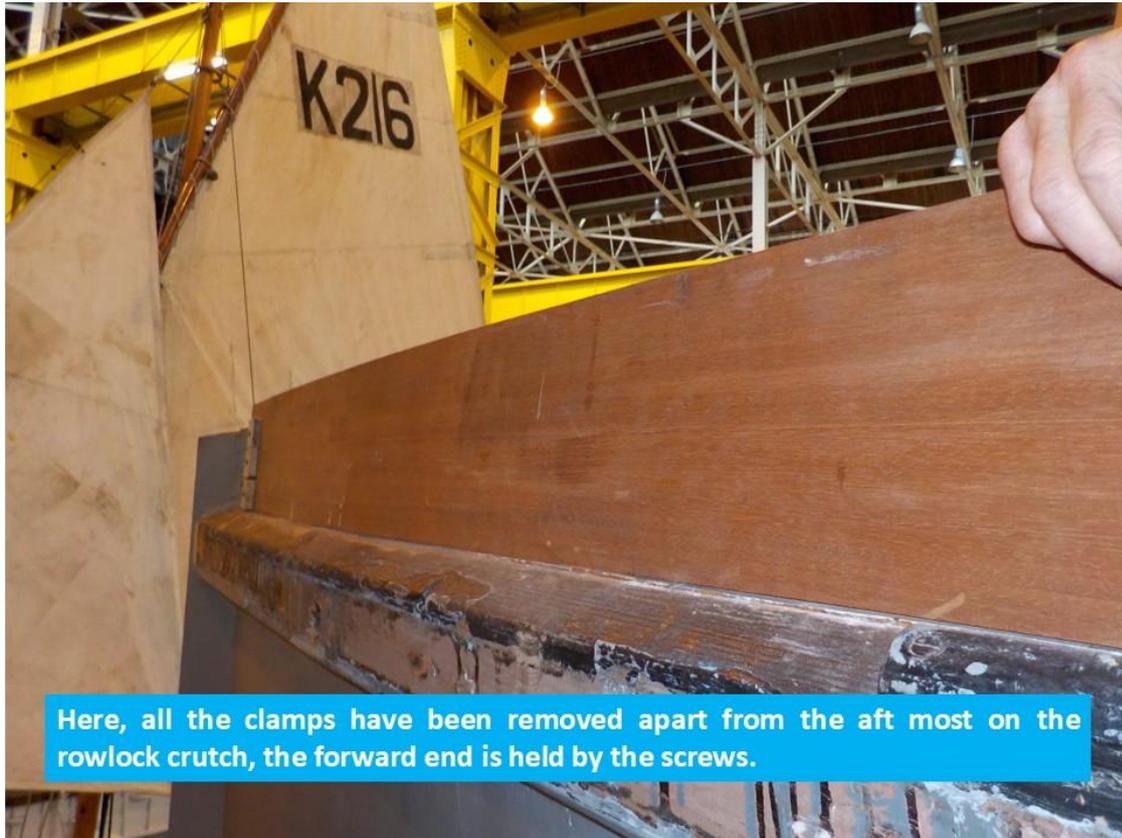
Here, all the clamps have been removed apart from the aft most on the rowlock crutch, the forward end is held by the screws.

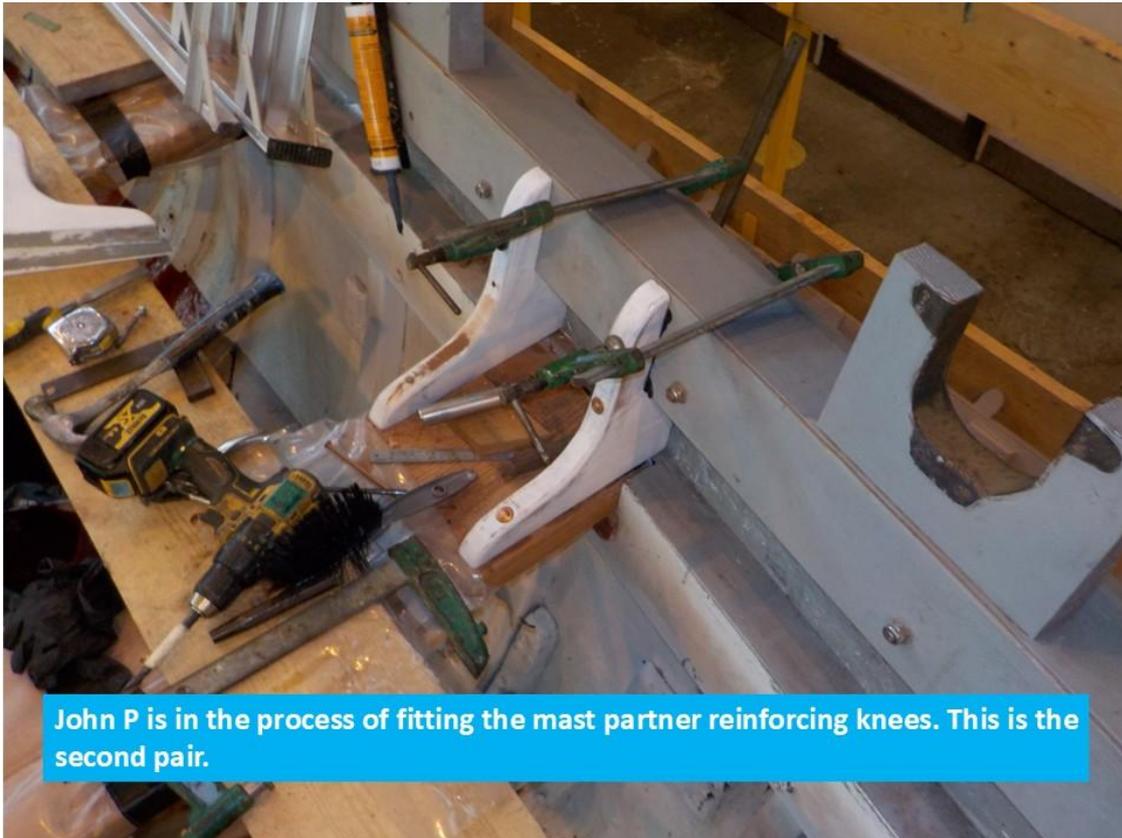
John P is in the process of fitting the mast partner reinforcing knees. This is the second pair.

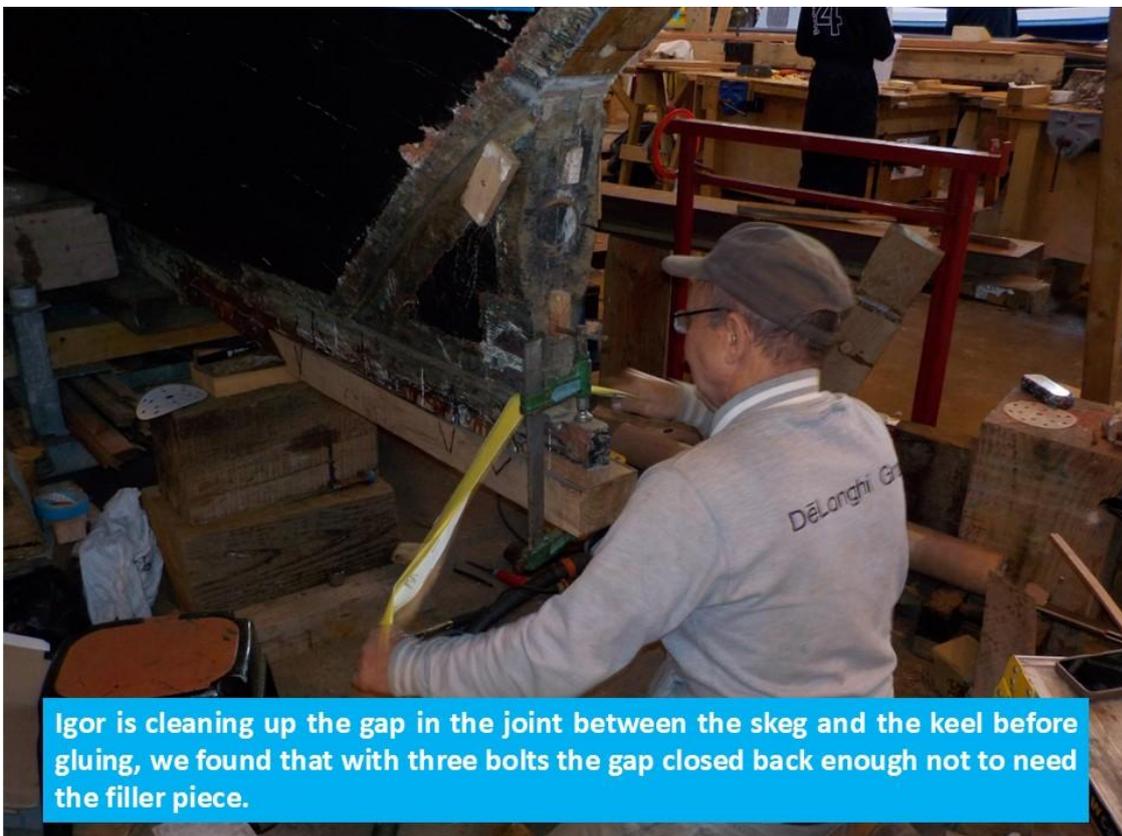
Igor is cleaning up the gap in the joint between the keel and the skag before gluing, we found that with three bolts the gap closed back enough not to need the filler piece.

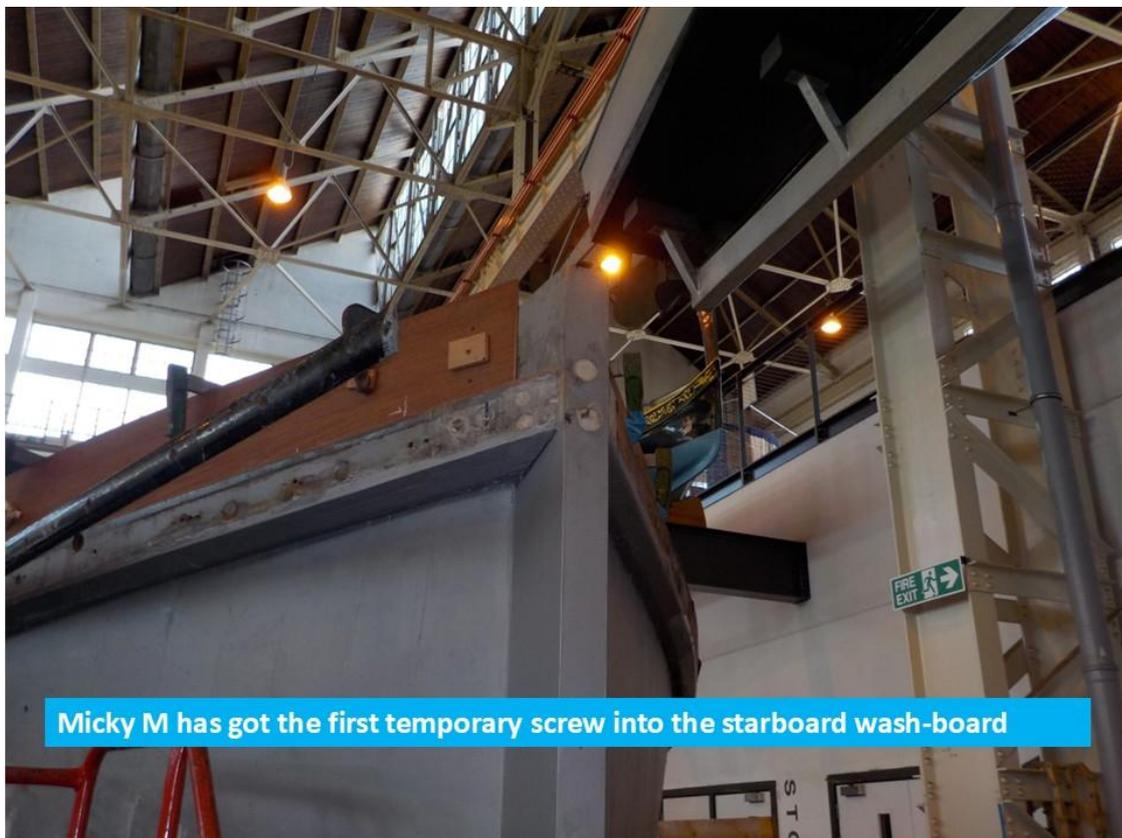
Micky M has got the first temporary screw into the starboard wash-board

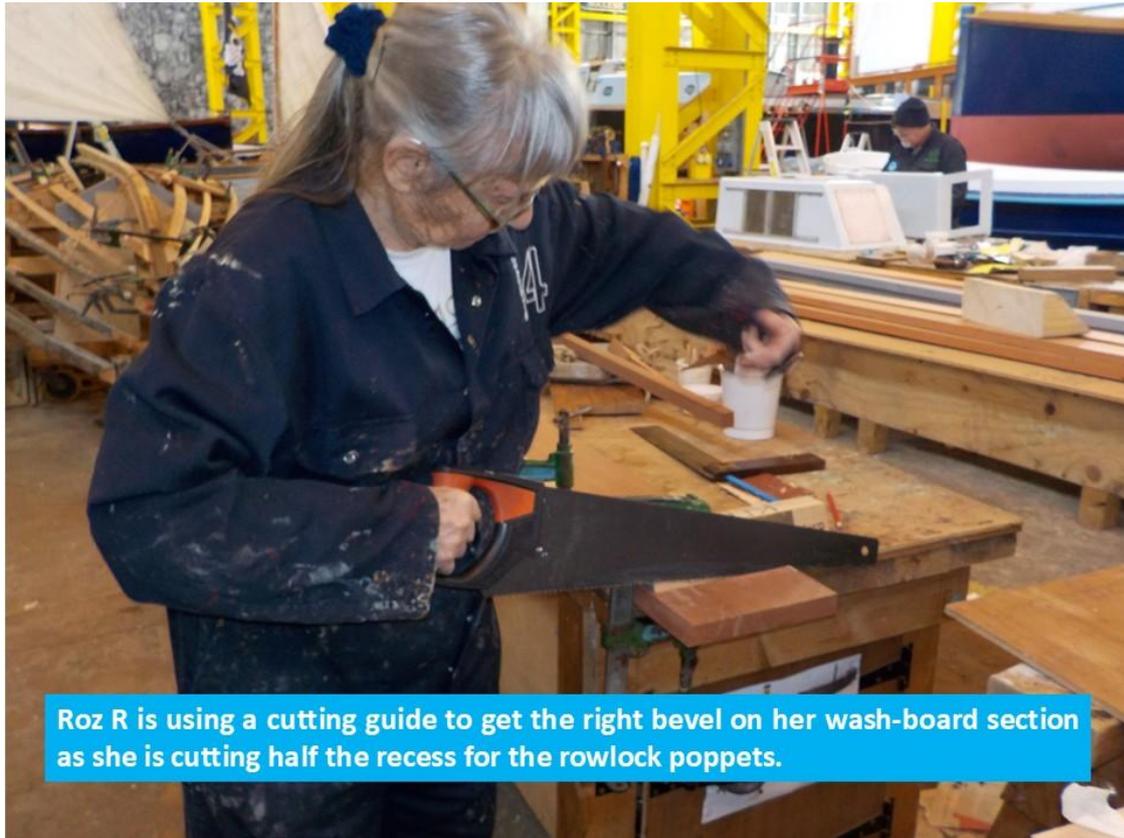
Roz R is using a cutting guide to get the right bevel on her wash-board section as she is cutting half the recess for the rowlock poppets.

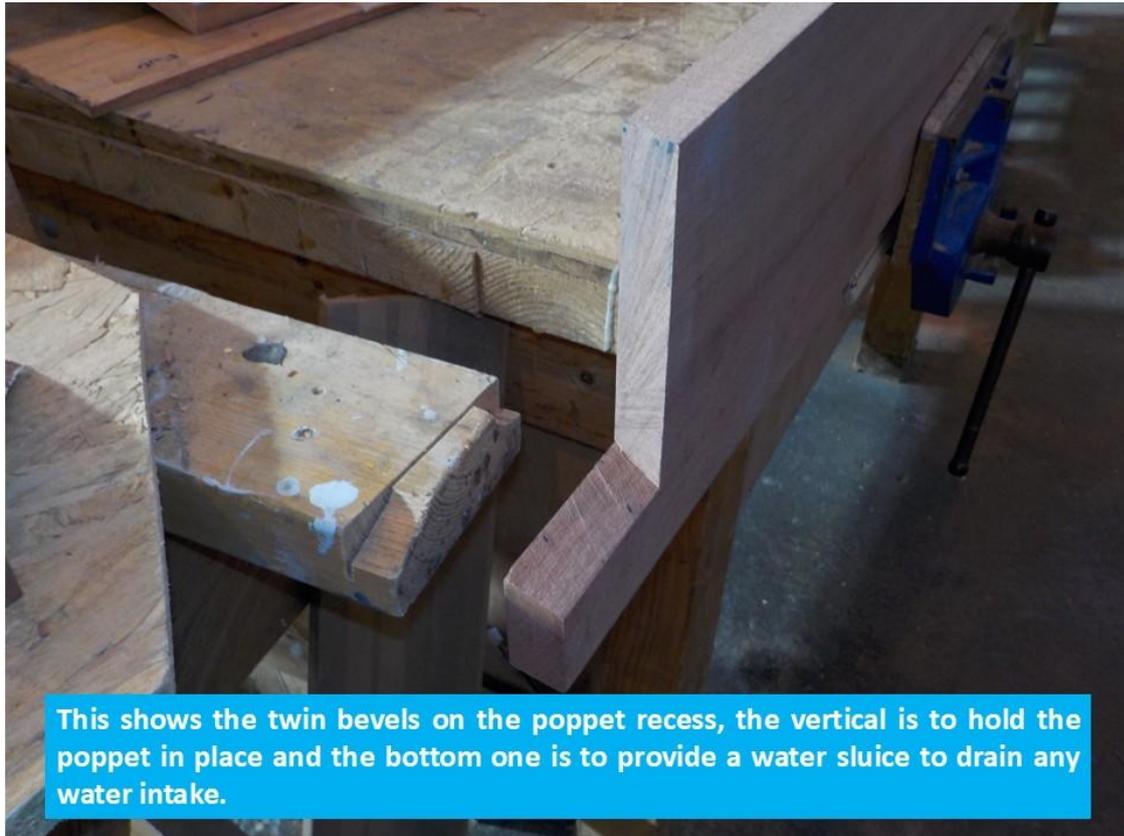
This shows the twin bevels on the poppet recess, the vertical is to hold the poppet in place and the bottom one is to provide a water sluice to drain any water intake.

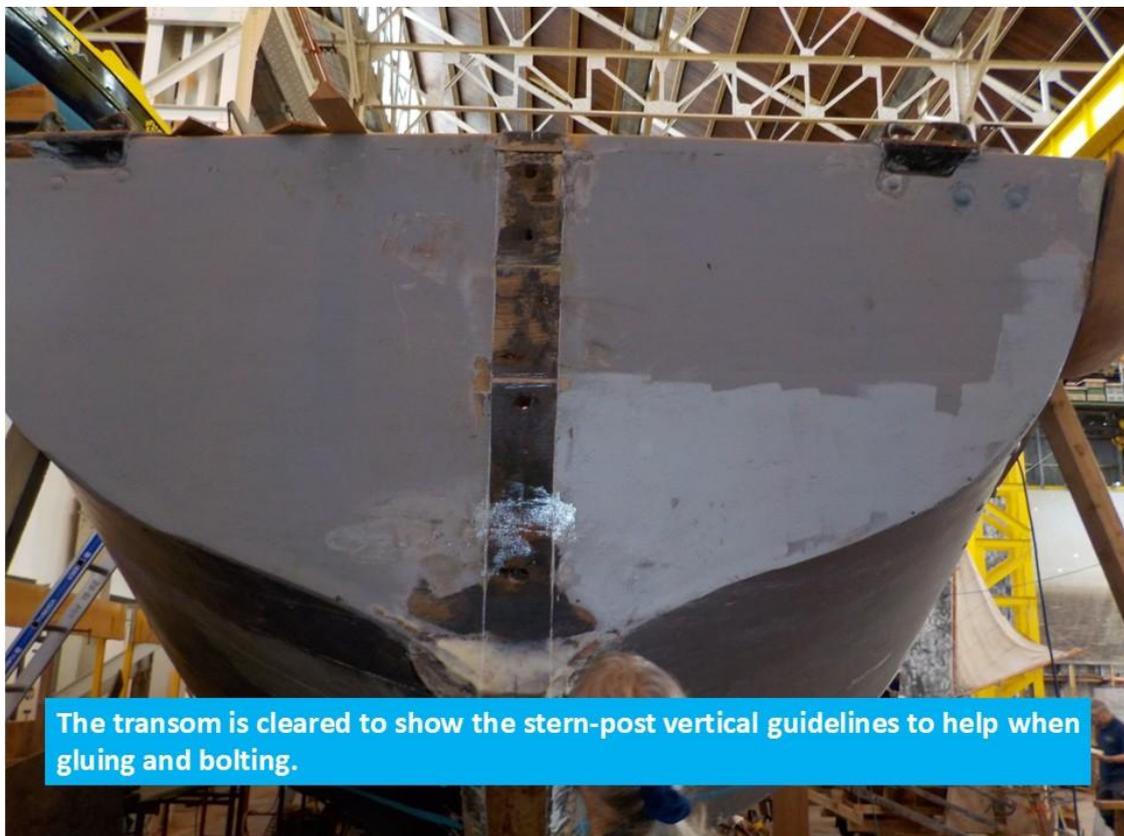
The transom is cleared to show the stern-post vertical guidelines to help when gluing and bolting.

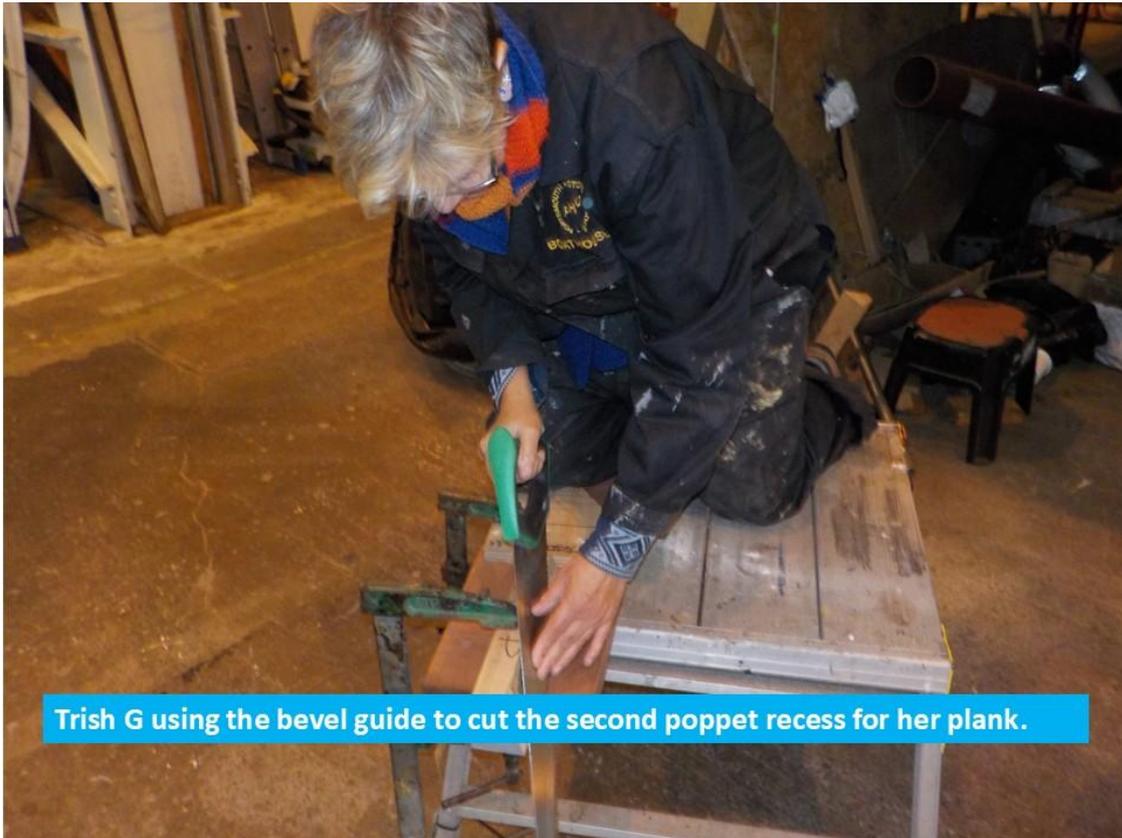
Trish G using the bevel guide to cut the second poppet recess for her plank.

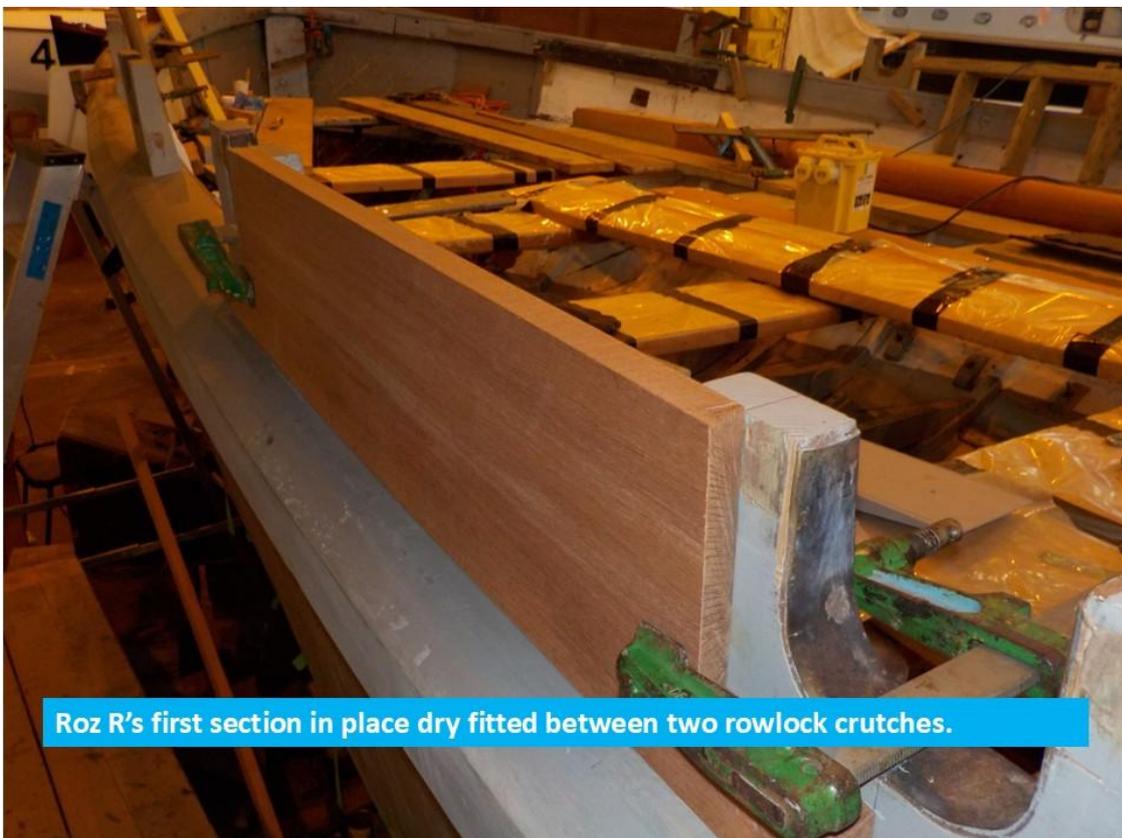
Roz R's first section in place dry fitted between two rowlock crutches.
